FAILURE ANALYSIS OF TAPPING SCREWS FRACTURE FOR

ENGINEERING APPLICATION

Fahai Ba* Guoqiang Yan

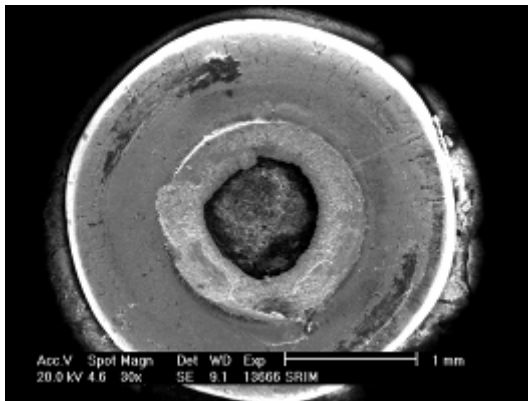
Fig.1 was failure screws macrograph, heads were separated from their shanks. the cross-slot had formed a throughout hole. And scarabs were observed in fracture. Some

FIGURE: 1 -SEM fractograph of fracture

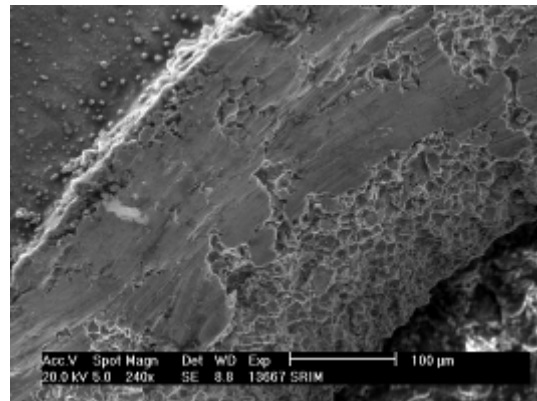
FIGURE: 2 -Scratch in the fracture

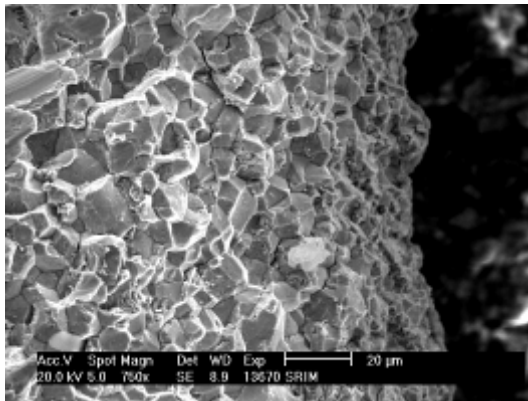
intergranular brittleness in inner of fracture and dimples in local area were also found (fig.2 to fig.4).

FIGURE: 3 - Intergranular fracture

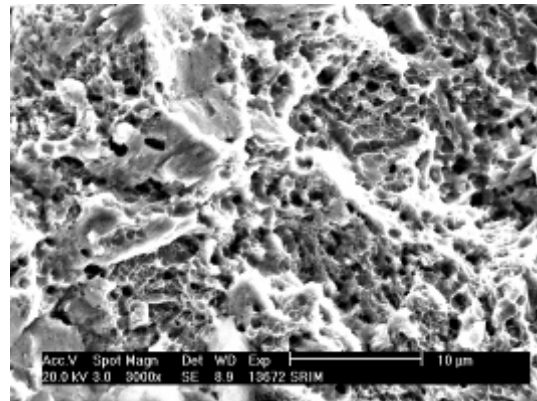
FIGURE:4 - Dimples in local area

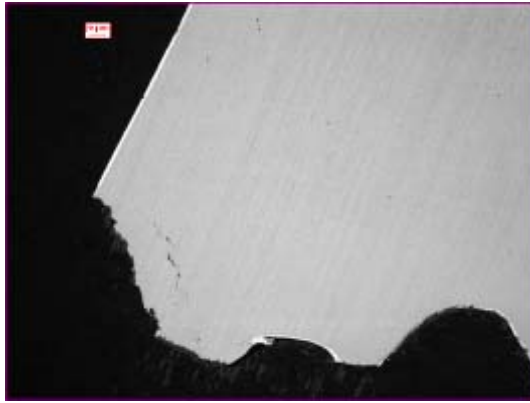
FIGURE: 5 – Polished state of fracture

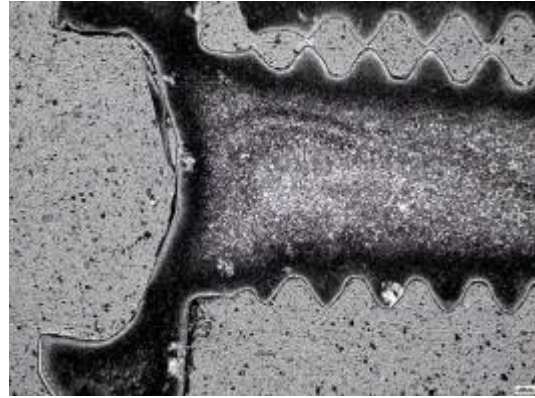
Metallographic test were showed in fig.5 to fig.7. That carbonization through the whole section between head and shank. Core microstructure was tempered sorbite with keeping martensite shape and carbonization layer was tempered troosite.(see also fig.6 to fig.7) .

FIGURE:6 – Section plane through center

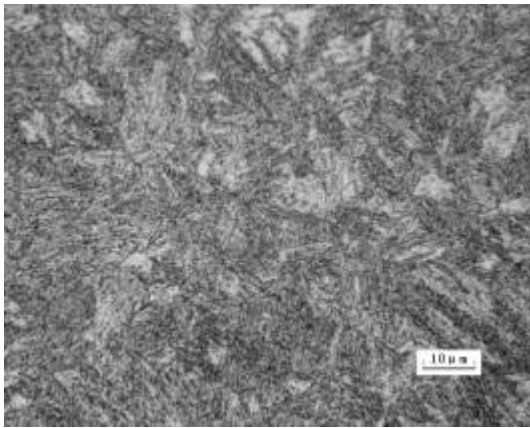
FIGURE:7 -Microstructure in the center of screw

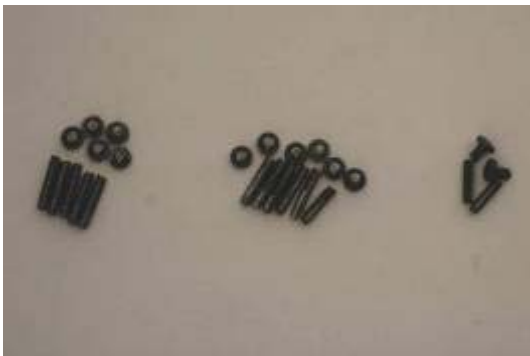
Next the overload test was made according fig.8, in this experiment the screws were exerted a overload torque until fracture. The average fracture torque was 0.58Nm, which was 2 times that of hydrogen test (left side in fig.9, fig.10). Observing the fractures with shearing dimples (fig.11) , fracture happened in the first tooth root other than above that (fig.9 and fig.10). However the screws were clamped at head and twisted till fracture, the average torque was 0.32Nm which reached the designed torque and the fracture site were as same as overload test (0.58Nm, middle in fig.9).

FIGURE: 9- Overload fracture

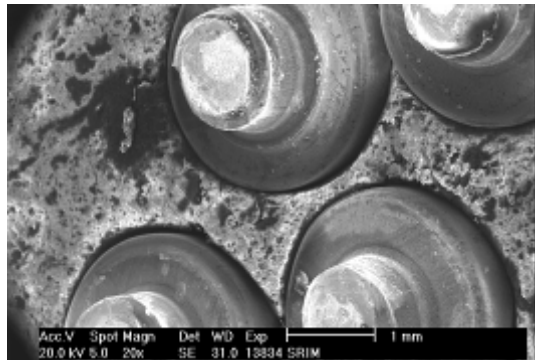
FIGURE: 10 Overload fracture

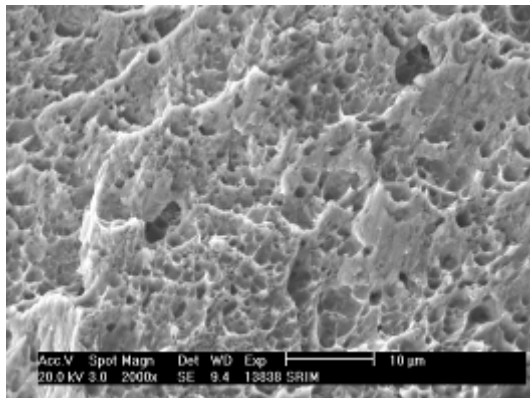
FIGURE:11 - Shear dimples in fracture
