FAILURE ANALYSIS OF TAPPING SCREWS FRACTURE FOR

ENGINEERING APPLICATION

Fahai Ba* Guoqiang Yan

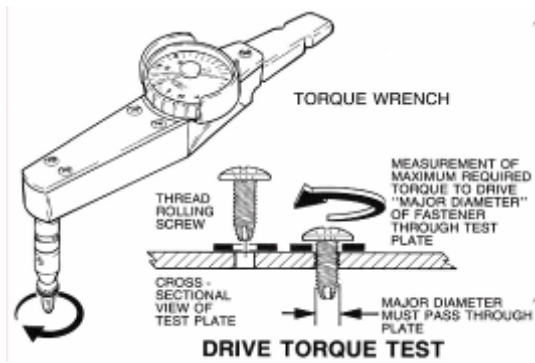
Next the overload test was made according fig.8, in this experiment the screws were exerted a overload torque until fracture. The average fracture torque was 0.58Nm, which was 2 times that of hydrogen test (left side in fig.9, fig.10). Observing the fractures with shearing dimples (fig.11) , fracture happened in the first tooth root other than above that (fig.9 and fig.10). However the screws were clamped at head and twisted till fracture, the average torque was 0.32Nm which reached the designed torque and the fracture site were as same as overload test (0.58Nm, middle in fig.9).

FIGURE: 8- Hydrogen embrittlement test sketch
